## CHAPTER 4 - CYCLIC LOAD TESTING OF SEMI- INTEGRAL BRIDGE ABUTMENTS

### 4.1. Introduction

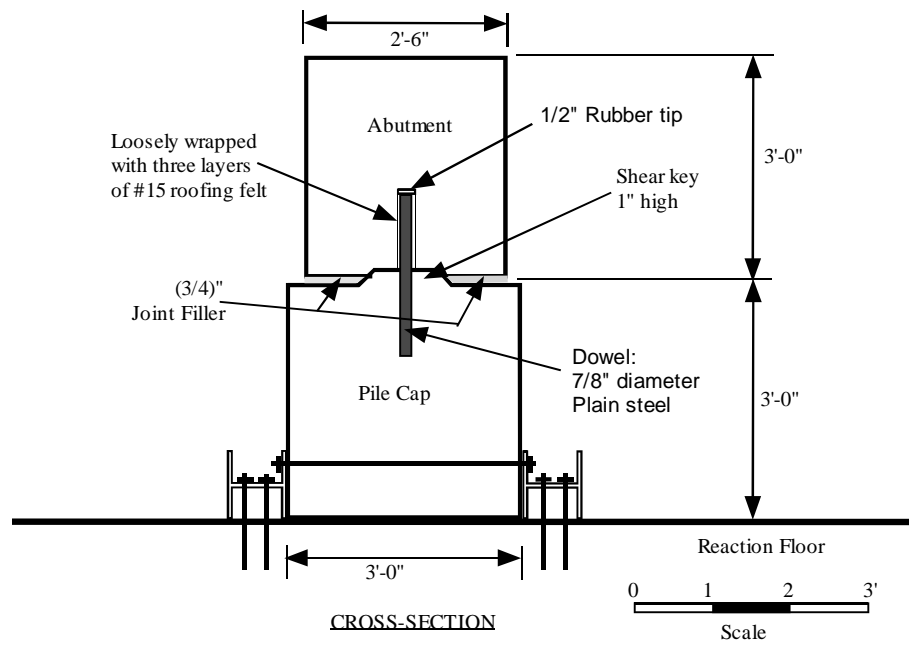
**Figure 4.1.** Schematic illustration of the initial VDOT semi integral abutment hinge

The Virginia Department of Transportation (VDOT) has developed a semi-integral abutment detail as seen in Figure 4.1. This abutment is expected to rotate over the pile cap. This rotation helps reduce the pile stresses by reducing the lateral displacement of the foundation piles and by reducing the moments transferred from the superstructure.

Two specimens with the original detail as illustrated in Figure 4.1 were constructed. The construction took place between November 1999 and January 2000. The pile cap block and the abutment block of the first specimen (Specimen A) were cast on November 23, 1999 and December 8, 1999, respectively. Similarly, the pile cap block and the abutment block of the second specimen (Specimen B) were cast on November 29, 1999 and January 5, 2000, respectively. Figure 4.3 presents photographs from the construction.

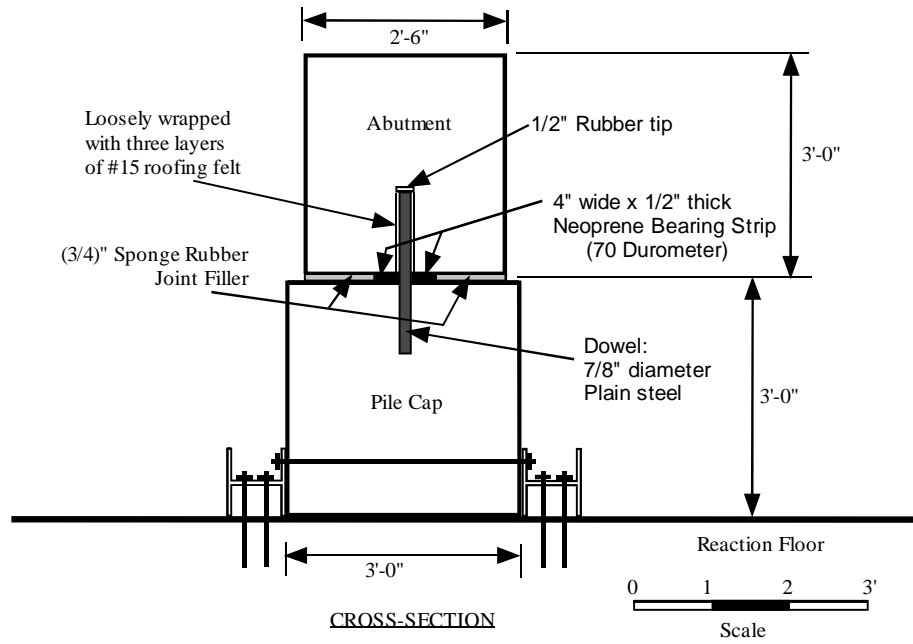
**Figure 4.2.** Schematic illustration of the revised VDOT semi integral abutment hinge

During static load tests of the first two specimens, a deficiency in the design was discovered. Upon consultation with the Staunton office of VDOT, a revised detail as illustrated in Figure 4.2 was developed by that office. The construction of the revised

In the first static loading test of the first abutment, the shear key had unexpectedly failed. The shear key of the second abutment had also failed in the same manner at exactly the same lateral load. Upon consultation with the Staunton office of VDOT, a revised detail was developed by that office. The revised detail can be seen in Figure 4.2. A third specimen based on the detail shown in Figure 4.2 was built. The revised detail did not show any failure mechanism.

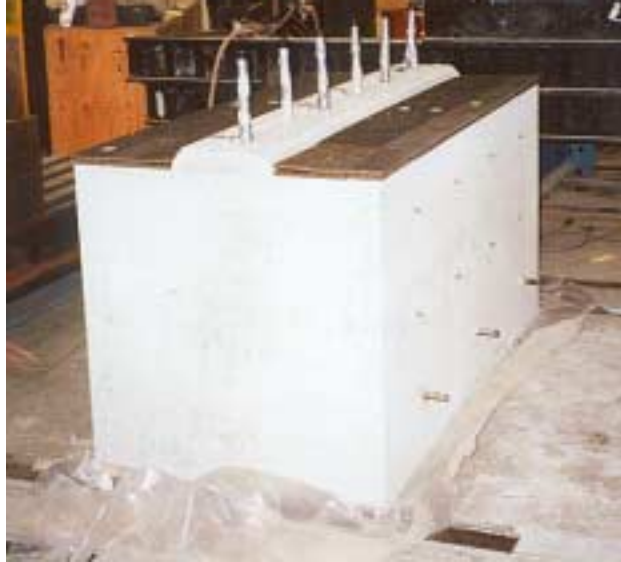
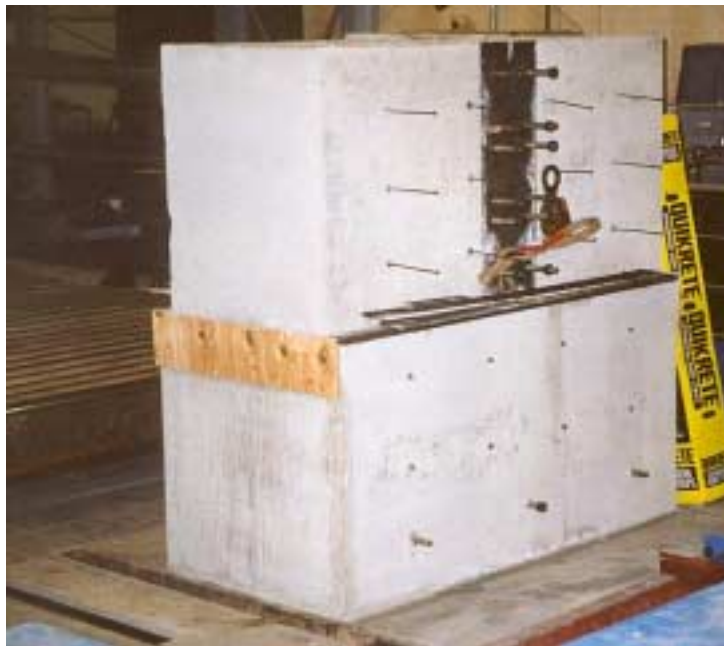
**Figure 4.3.** Pictures from construction of the initial VDOT semi integral abutment hinge

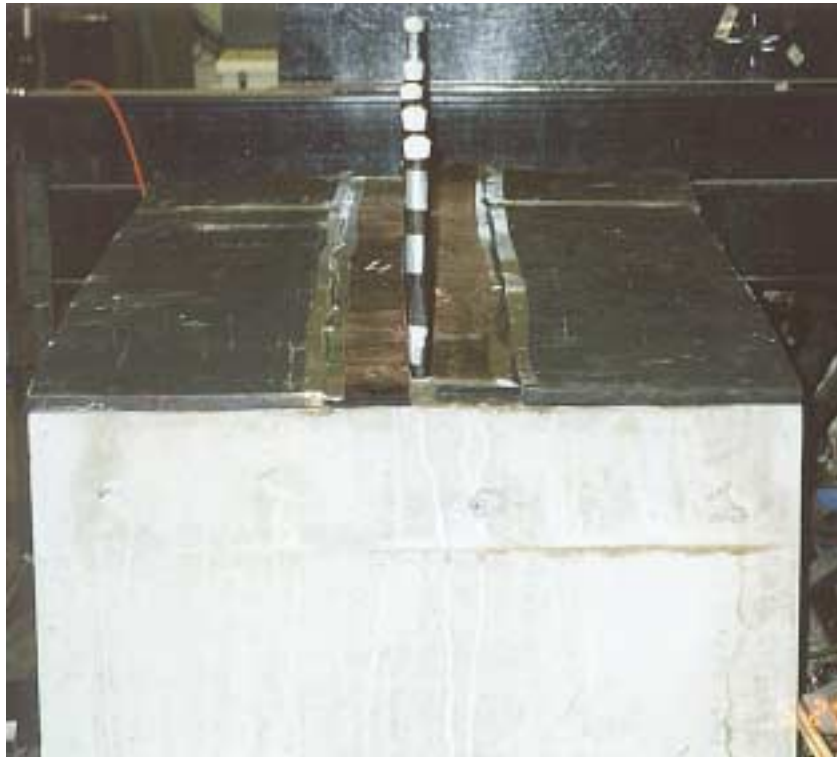
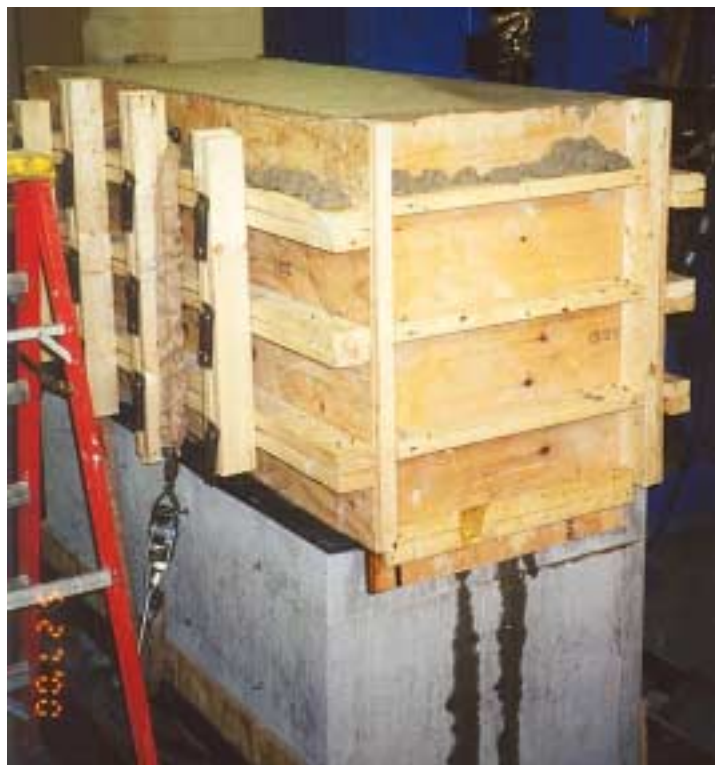
**Figure 4.4.** Pictures from construction of the revised VDOT semi integral abutment hinge

detail was completed in May 2000. The pile cap block of Specimen B was re-used. After removing the abutment of Specimen B, the surface of the pile cap was leveled and cleaned. One of the dowels was damaged during the removal of the abutment. A new dowel was driven inside the existing hole into the pile cap. Epoxy was placed inside the hole before the dowel was driven in to assure proper bonding between the concrete and the dowel. The revised detail was built on the surface of this recycled pile cap. Figure 4.4 presents photographs from the construction of the revised detail (Specimen C).

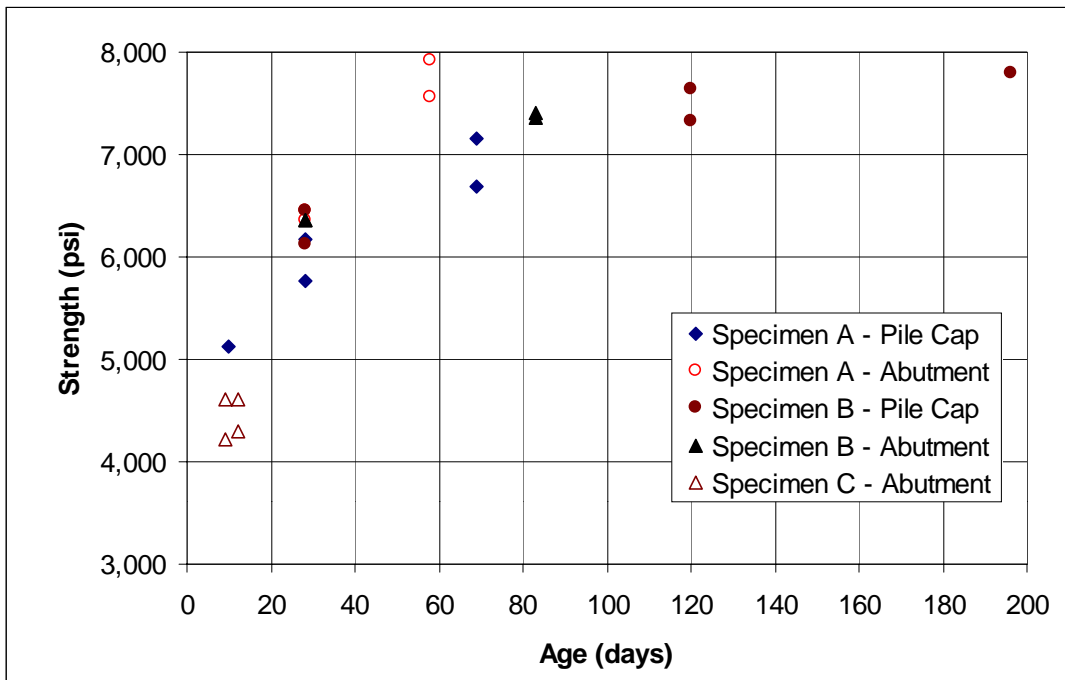
**Figure 4.5.** Increase in strength of concrete with time

Concrete slump was checked for each batch received before placing the concrete. The slump varied from 3-½ to 4 inches. Concrete samples from each batch were collected and compressive strengths of these samples were determined on the day of testing. Compressive strength and other useful properties of concrete for each member of the specimens are summarized in Table 4.1. Young's modulus of the concrete is calculated by  $E = 57,000\sqrt{f'_c}$ , where  $f'_c$  is the strength on the test day in psi. Additional concrete samples were taken to establish the strength increase of the concrete over time. Variation of the strength of the concrete with time is portrayed in Figure 4.5.

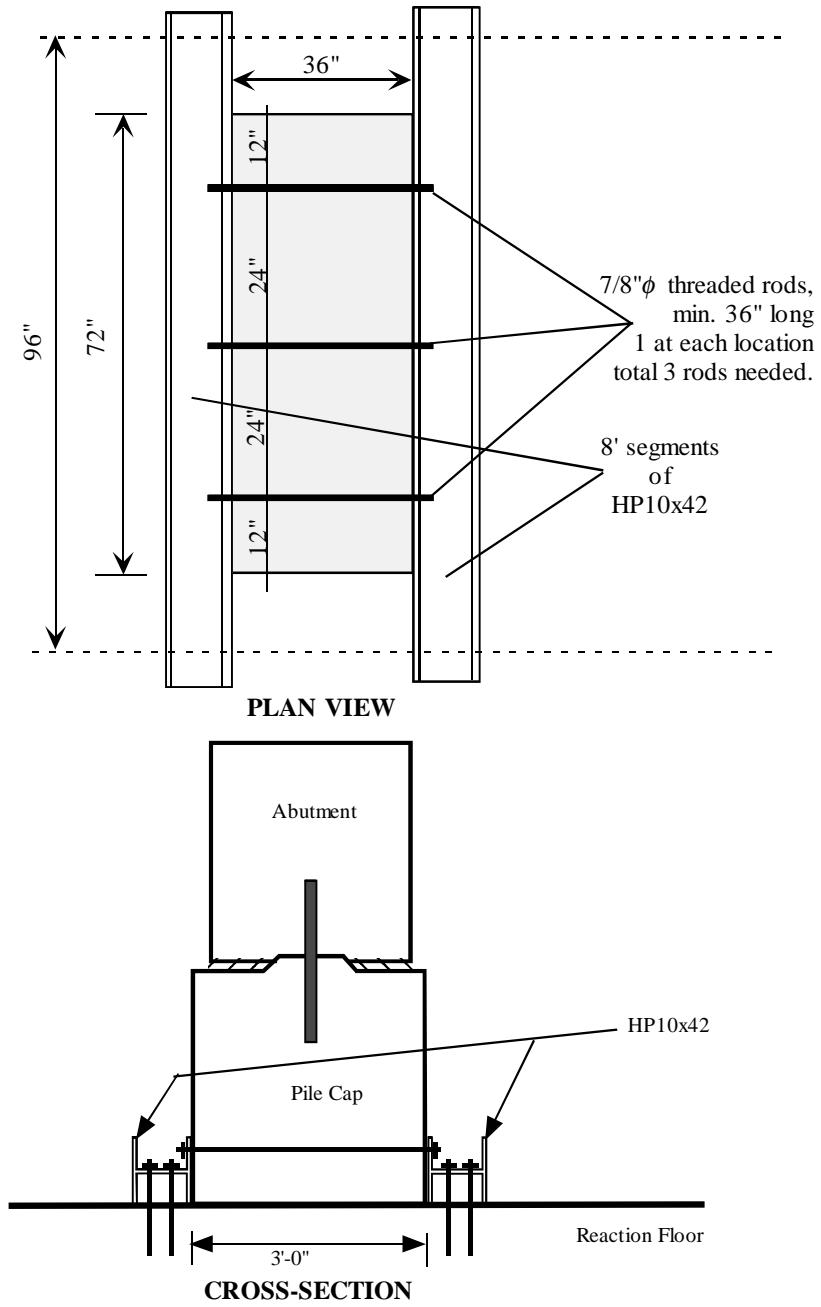
**Figure 4.6.** Schematic illustration of mounting pile caps on reaction floor

Three threaded rods were placed in each pile cap during construction such that the rods extend out of the cap. On each side of a pile cap, an 8-foot segment of a HP10x42 is bolted on the threaded rods that are protruding from the pile cap. Figure 4.6 shows the locations of the threaded rods, and the floor-mounting plan of the pile caps. The HP10x42 segments were bolted down to the reaction floor at each corner by four threaded steel rods.

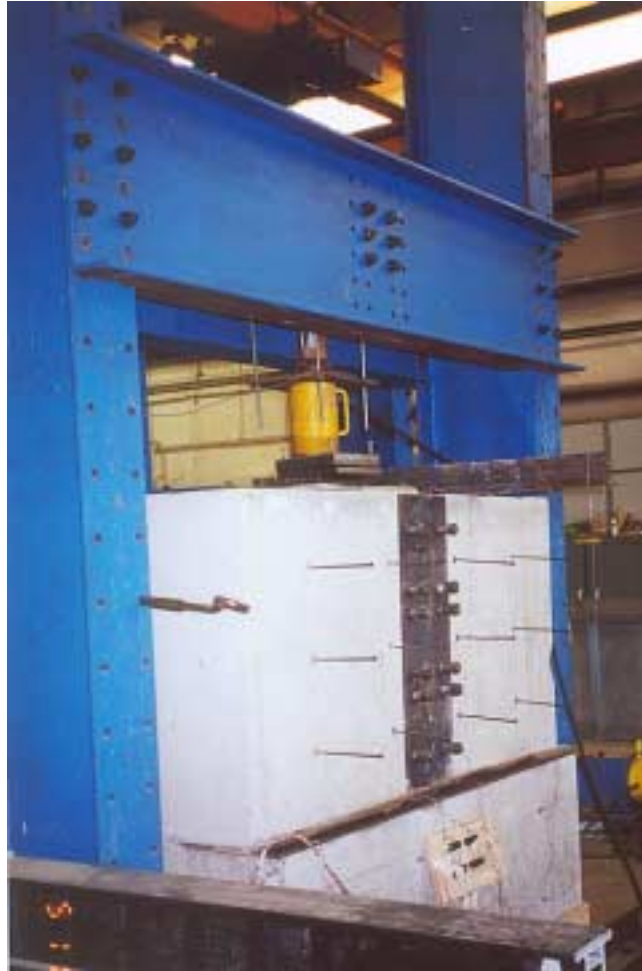
**Figure 4.7.** Setup used to apply vertical load to specimens

The stiff steel frame was built around the specimens as pictured in Figure 4.7 to support the vertical loading ram. Loads were applied by a single-acting hydraulic ram. A compression load cell was placed between the frame and the ram.

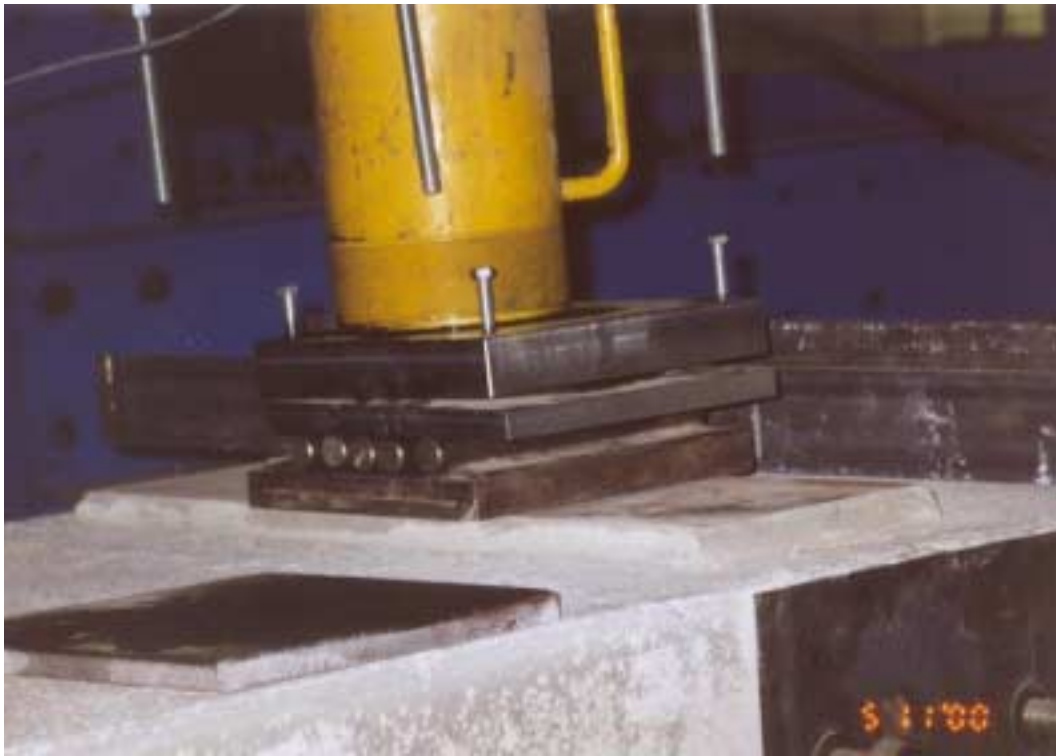
**Figure 4.8.** Roller and tilting-plate assembly used between ram and specimen

A roller and tilting-plate mechanism was placed between the specimen and the vertical load ram in order to minimize the lateral load transfer at this location. A picture of this assembly is presented in Figure 4.8.

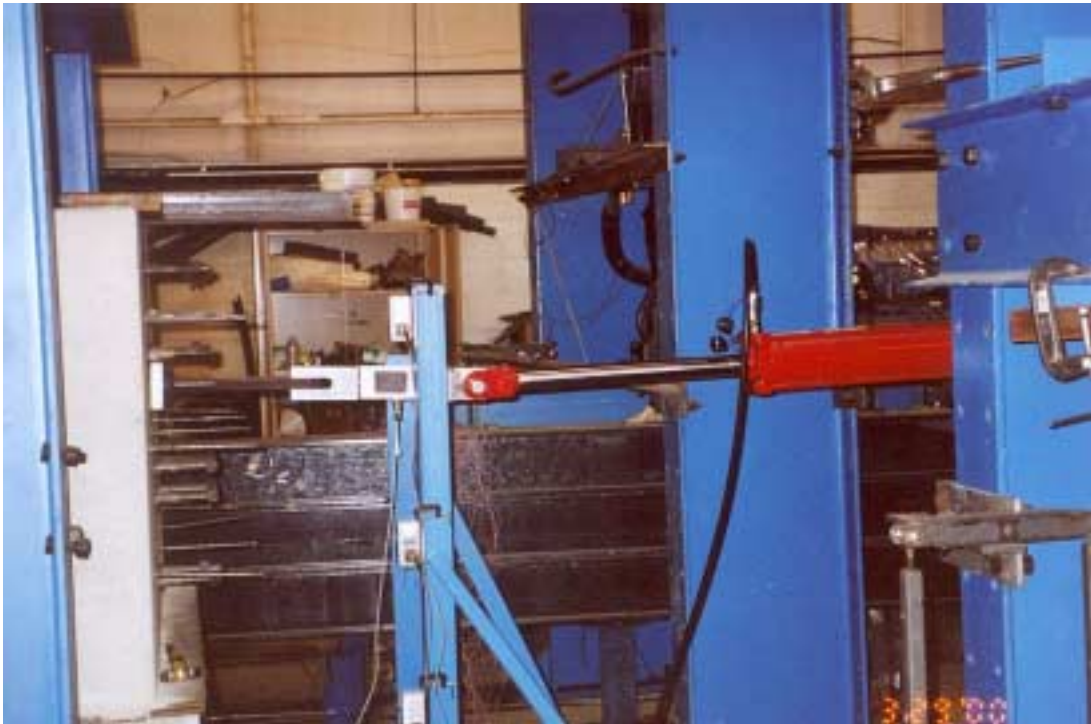
**Figure 4.9.** Setup used to apply static lateral load

A manually controlled hydraulic ram capable of applying 50 kips of load was used to apply the static lateral loads. A view of the setup used is pictured in Figure 4.9. Support for the ram was provided by an A-shaped large stiff frame. A 50-kip tension load cell

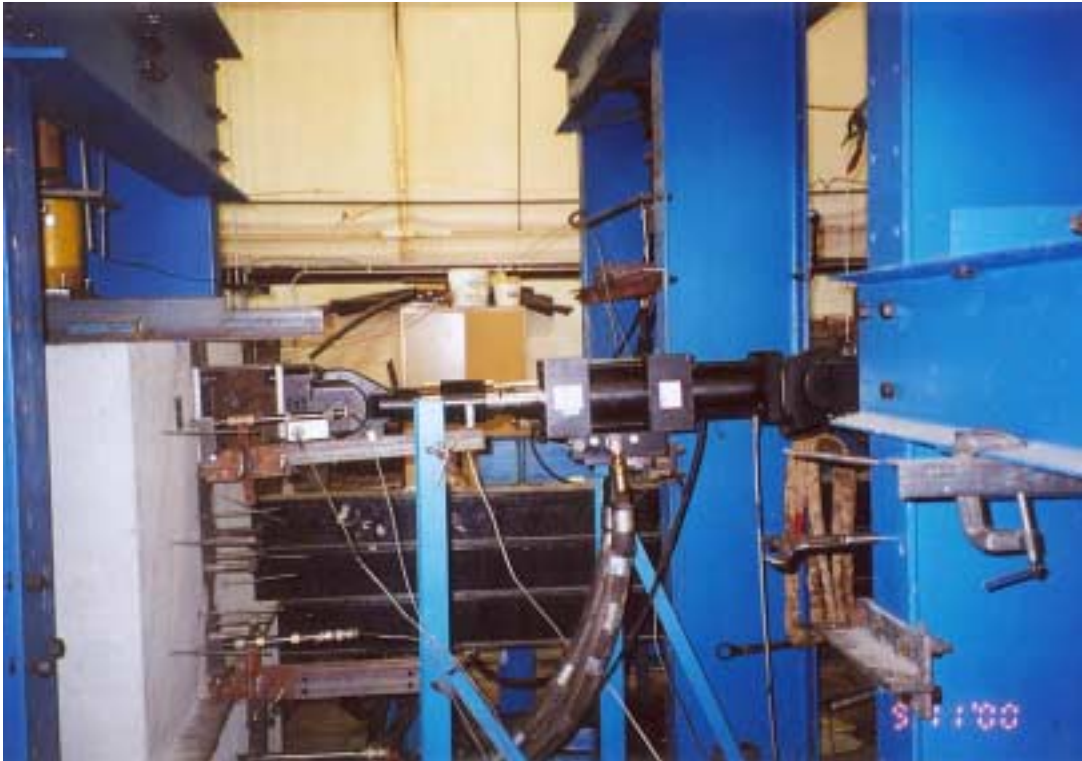
**Figure 4.10.** Setup used to apply cyclic lateral load

A computer controlled MTS hydraulic actuator capable of applying  $\pm 50$  kips of load and  $\pm 3$  inches of displacement was used to impose cyclic lateral loads. Support for the ram was provided by the same A-shaped large frame used in the static load tests. A view of the actuator during testing is shown in Figure 4.10. The system was capable of applying both push and pull forces.

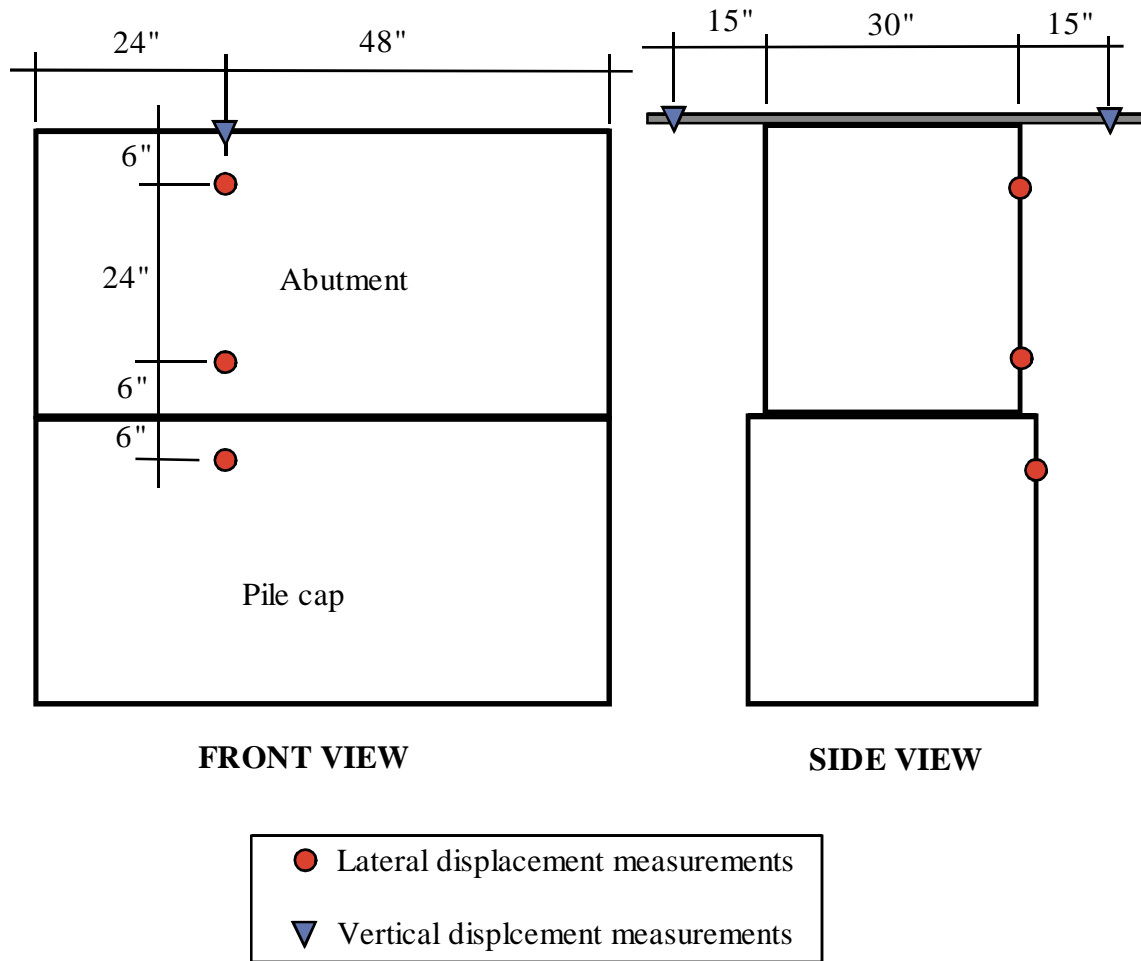
**Figure 4.11.** Locations of displacement measuring devices

Displacement measurements were made by wire pot transducers. Each transducer was calibrated on-site right before it was put into service. Five transducers were used during each test. For convenience, the locations of the transducers were kept the same in all tests. Three of these transducers measured the lateral displacements of the abutment while the remaining two were used to record the vertical displacement of the abutment at the top. Figure 4.11 shows the locations of the displacement measuring devices.

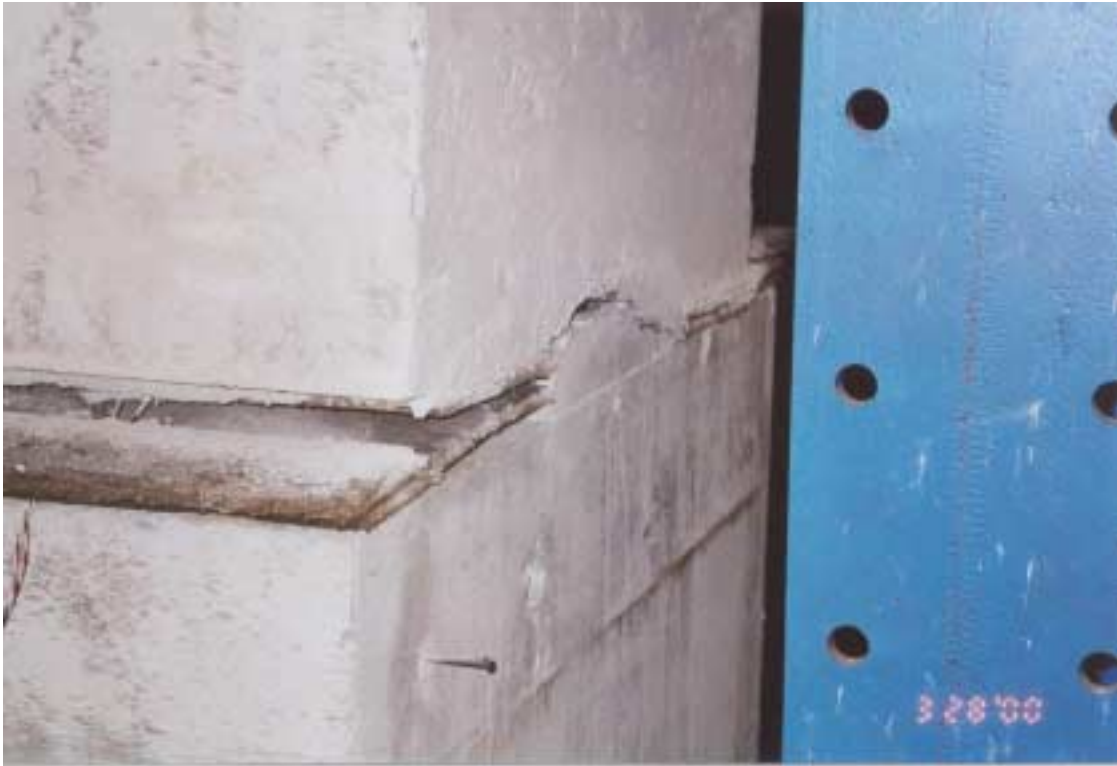
**Figure 4.12.** Picture of failed shear key

In the first static test of Specimen A, the shear key of the specimen failed with a loud noise. At the time of the failure, the lateral was about 34 kips applied 29 inches above the shear key. No vertical load was applied to the sample other than its self-weight. A picture of the failed shear key is shown in Figure 4.12.

Analysis of the data indicates that the abutment and the pile cap rotated as a single structural unit prior to failure of the shear key. This suggests that the cold bond between the pile cap and the abutment was as strong as if they were cast together. The lateral load at the time of failure was calculated to generate a tensile stress of about 550 psi in the concrete of the shear key. This stress is within the estimated tensile strength range of the specimen.

It was concluded that the failure of the shear key was due to concrete of the shear key failing in tension due to bending. Static load tests were conducted after the shear key failure and found that both abutments were able to provide shear resistance, assuring that the dowels did not fail and the failure was limited to the concrete of the shear key. Unfortunately, all of the strain gages were lost at the time the shear key failed.

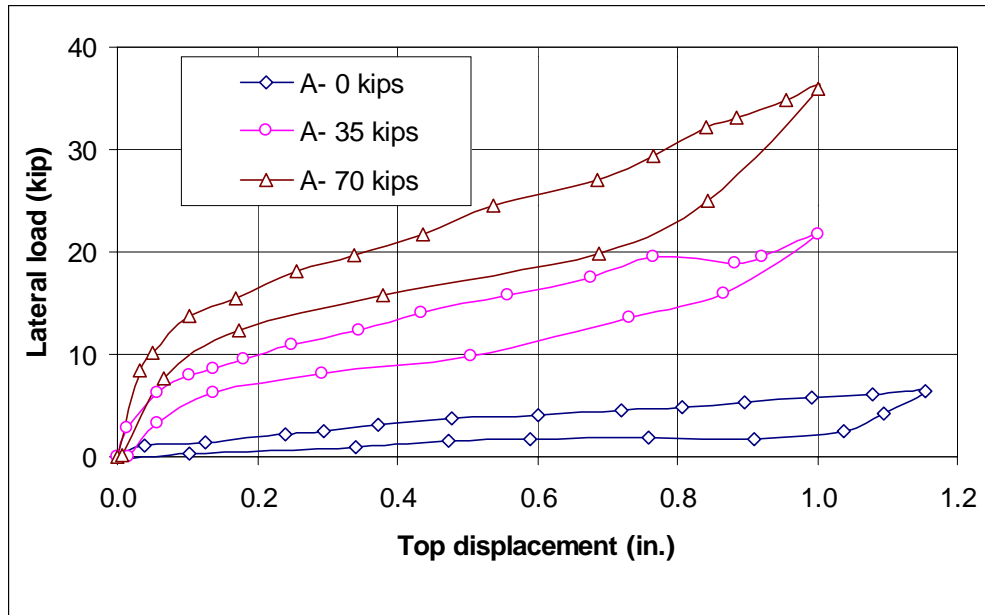
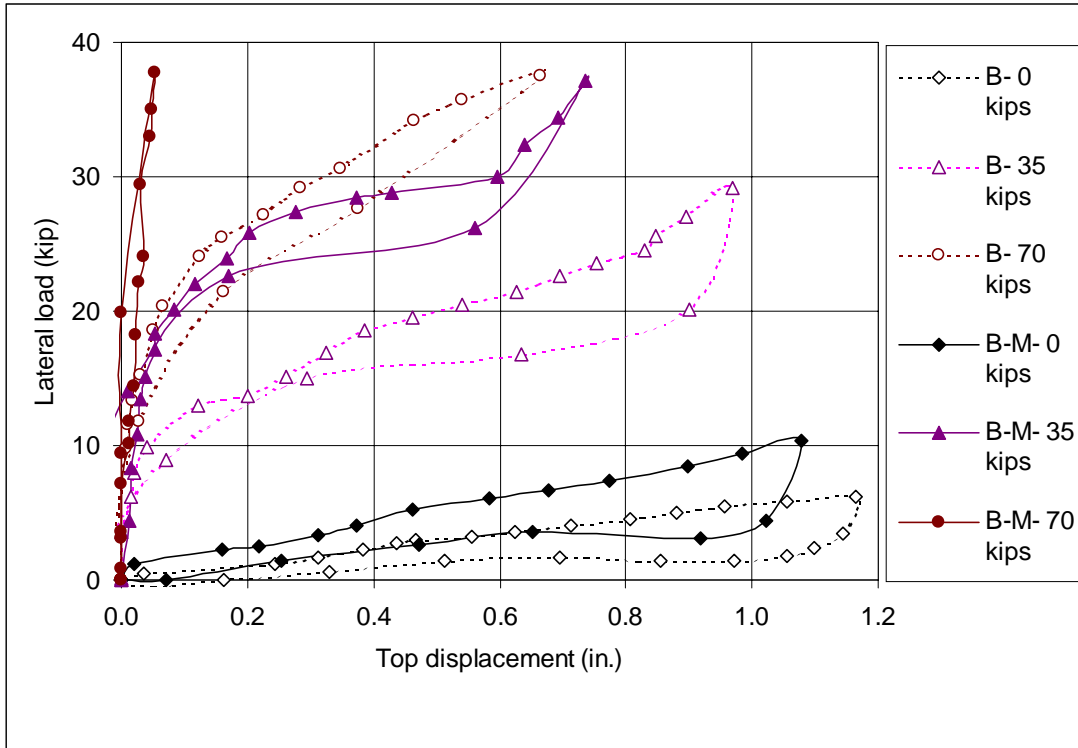
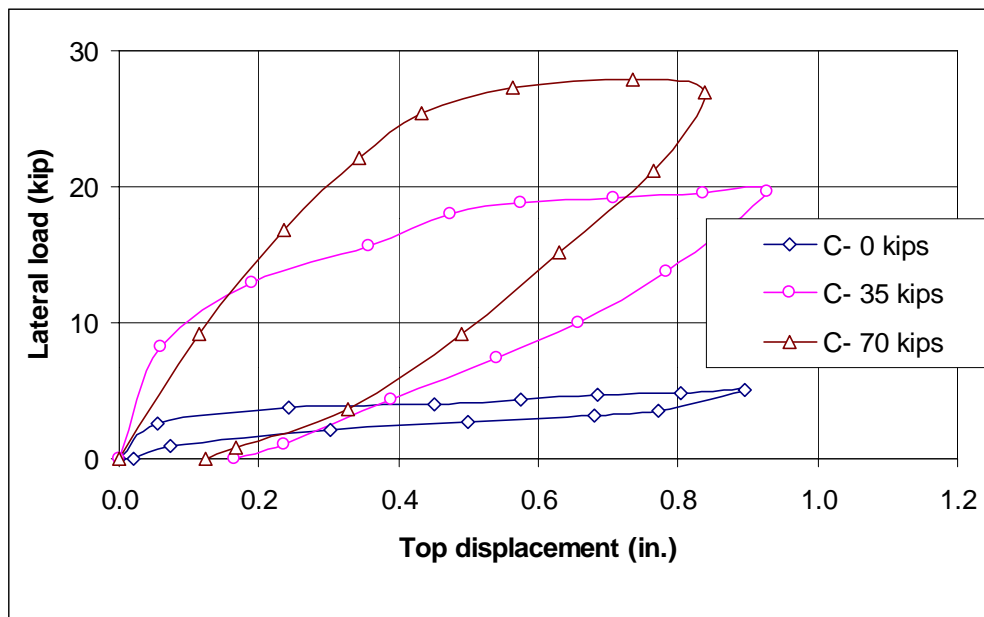
Figure 4.13. Lateral load/displacement relation of Specimen A for various vertical loads

**Figure 4.14.** Lateral load/displacement relation of Specimen B for various vertical loads

Figure 4.15. Lateral load/displacement relation of Specimen C for various vertical loads

The relationship between the lateral load and the relative displacement at the top of the abutment is shown in Figures 4.13, 4.14, and 4.15 for Specimens A, B, and C, respectively. Figures 4.13 and 4.15 contain three load/displacement curves for the vertical loads of 0, 35, and 70 kips applied on the abutments to simulate the dead load of the bridge. In Figure 4.14, lateral load/displacement responses of the abutment are shown for two different points of lateral load application. Half of the data shows the response of the abutment under three levels of vertical load (0, 35 and 70 kips) when the lateral load was applied 31 inches above the top of the pile cap. The other half of the data shows the response of the abutment under three levels of vertical load (0, 35 and 70 kips) when the lateral load was applied 22 inches above the top of the pile cap. As seen in the figures, the loading/unloading curves for the original semi-integral abutment hinge (Specimen A and Specimen B) are much closer to each other than the loading/unloading curves of the revised detail (Specimen C).

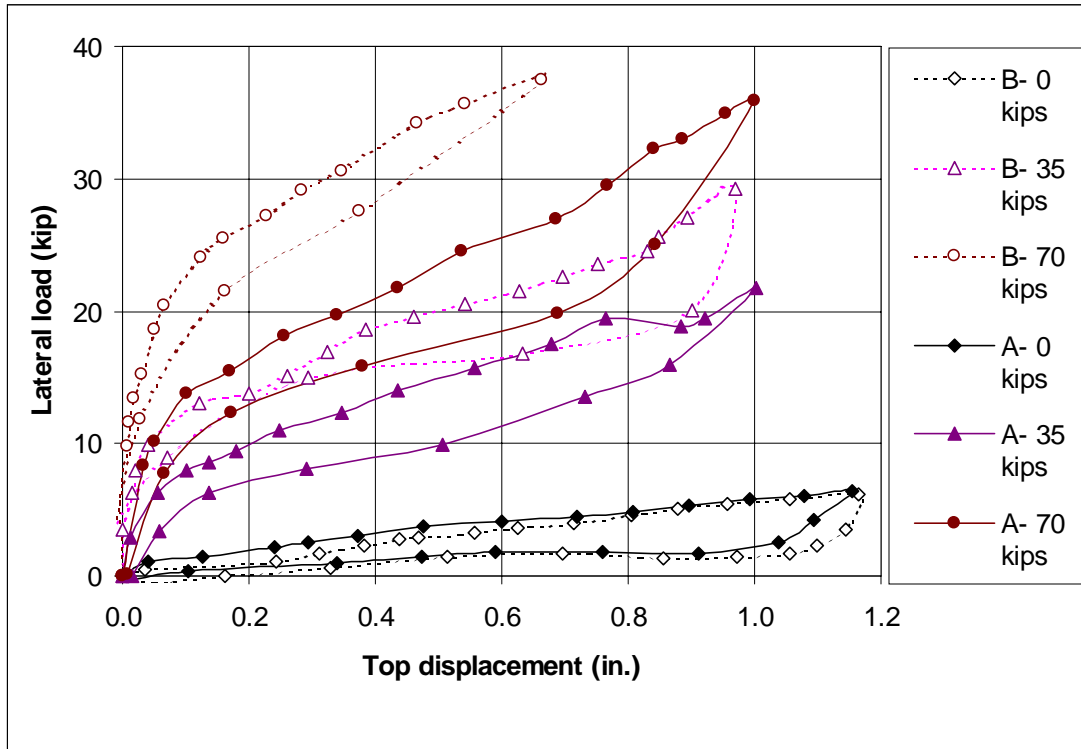
**Figure 4.16.** Comparison of lateral load/displacement relations of Specimens A and B

Lateral load/displacement relations of Specimen A and Specimen B are portrayed in Figure 4.16. As seen in the figure, the behavior is almost identical for zero vertical load. For other vertical loads, Specimen A consistently has higher lateral load response for a given displacement. This may be due to the fact that the irregular failure surface of the shear key caused the two abutments to have different points of rotation for the same lateral displacement at the abutment. Another factor could be that the roller and the

tilting-plate assembly used under the vertical loading ram provided different resistance for the two specimens, resulting in different lateral loads for a given displacement.

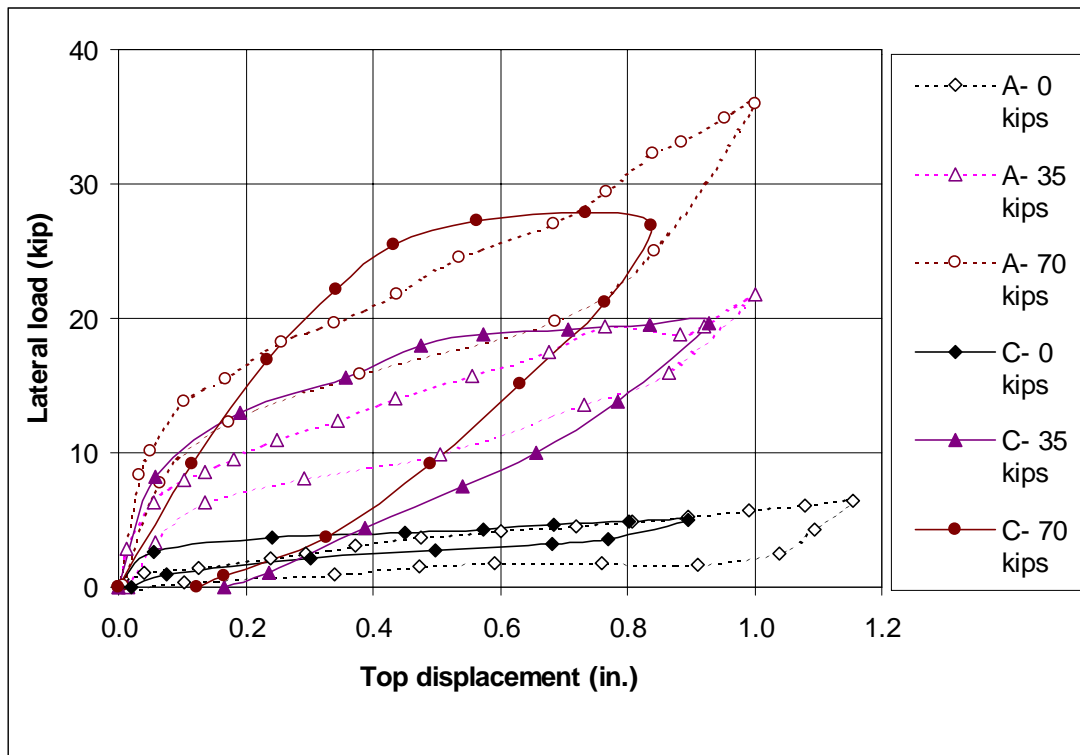
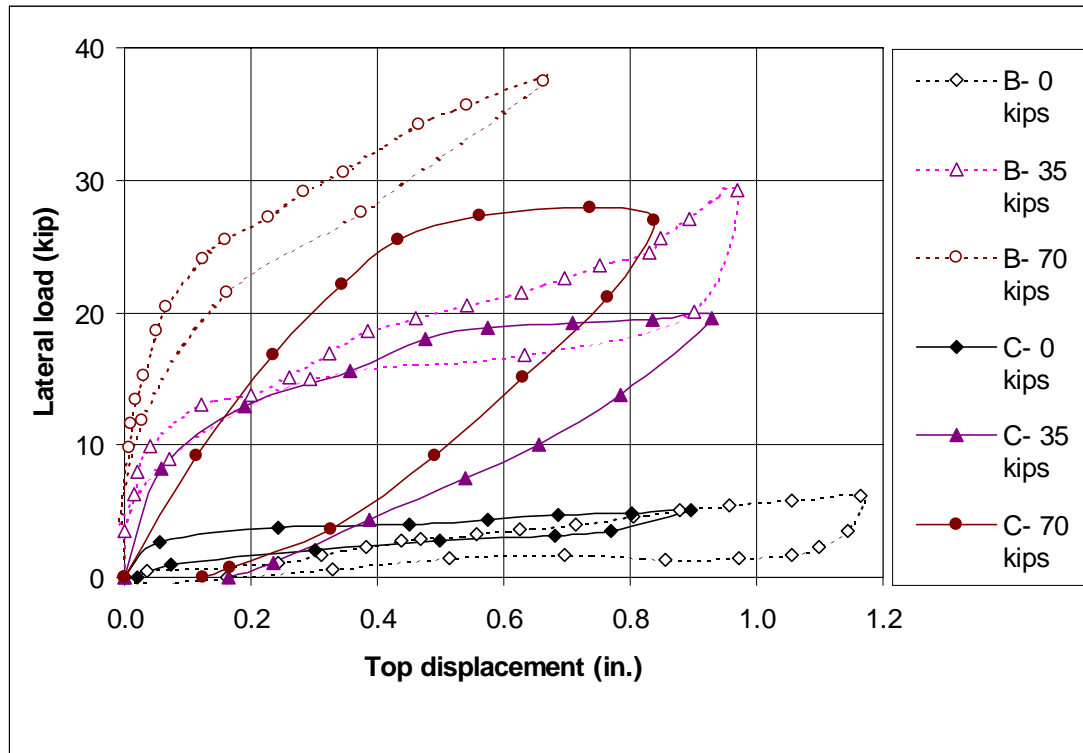
Figure 4.17. Comparison of lateral load/displacement relations of Specimens A and C

Figure 4.18. Comparison of lateral load/displacement relations of Specimens B and C

Figure 4.17 and Figure 4.18 compare the response of the revised abutment detail (Specimen C) to Specimen A and Specimen B, respectively. It is clear that the initial response of the revised abutment is stiffer than that of the other two specimens for zero vertical loading. Because of the discrepancy between Specimen A and Specimen B for other values of vertical loads, the trend in load response between the initial and the revised semi-integral abutment is not clear.

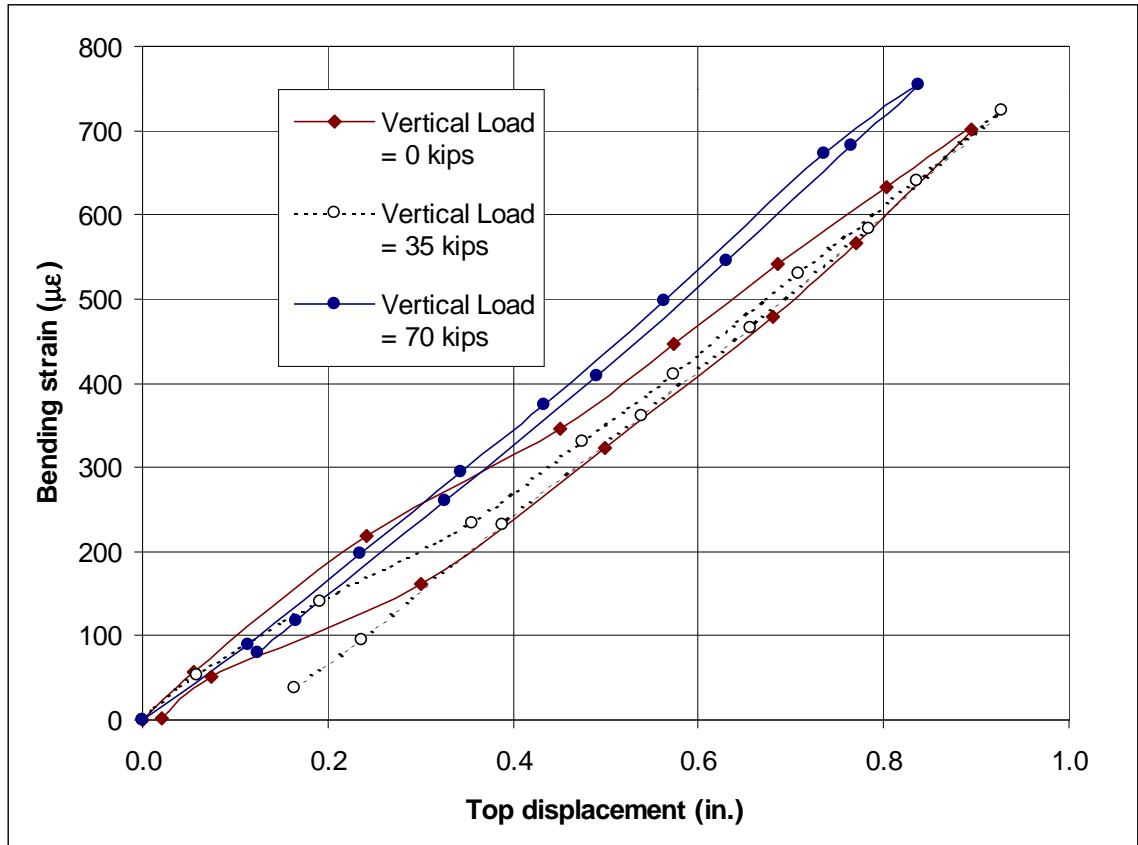
**Figure 4.19.** Bending strains measured on dowels of Specimen C

Bending strains of the dowels were recorded during static loading of Specimen C under various vertical loads and presented in Figure 4.19. Strains were averaged from all channels and were plotted against the relative lateral displacement of the top of the abutment. As seen in the figure, the strain/displacement relationship is approximately linear. The maximum strain measured during the tests is about 50 % of the yield strain of the dowels. The yield strain of the dowels is slightly over 1,400  $\mu\epsilon$ . Bending strains of the test when the vertical load was 70 kips are about 10% higher than other two tests.

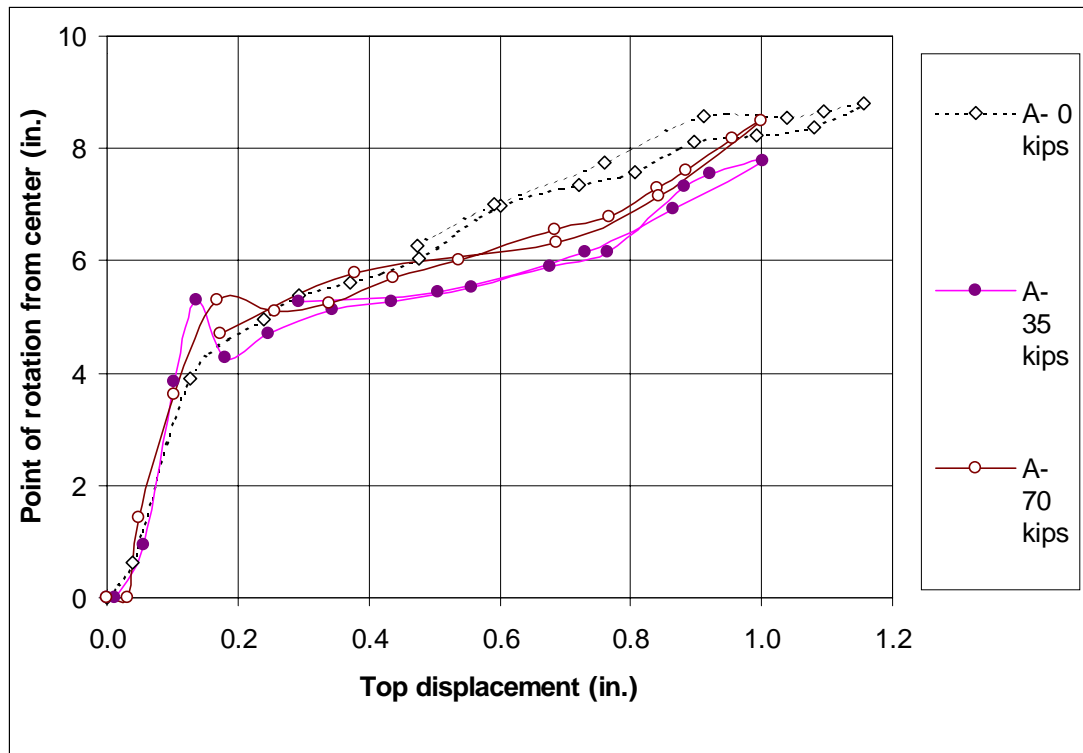
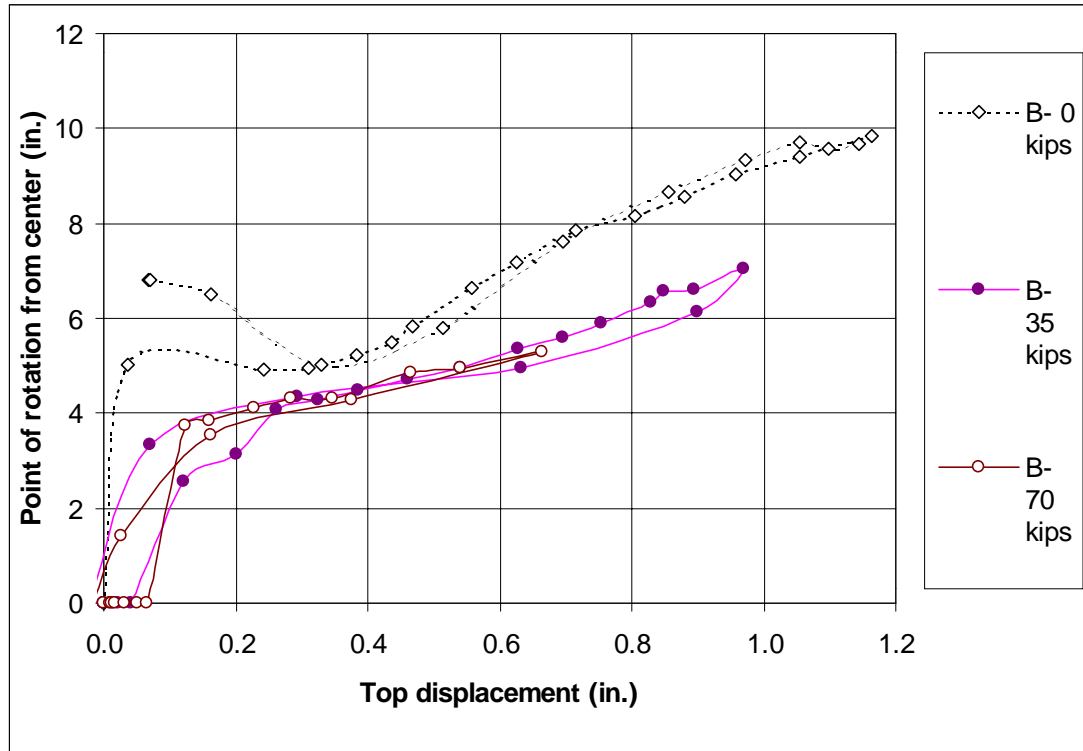
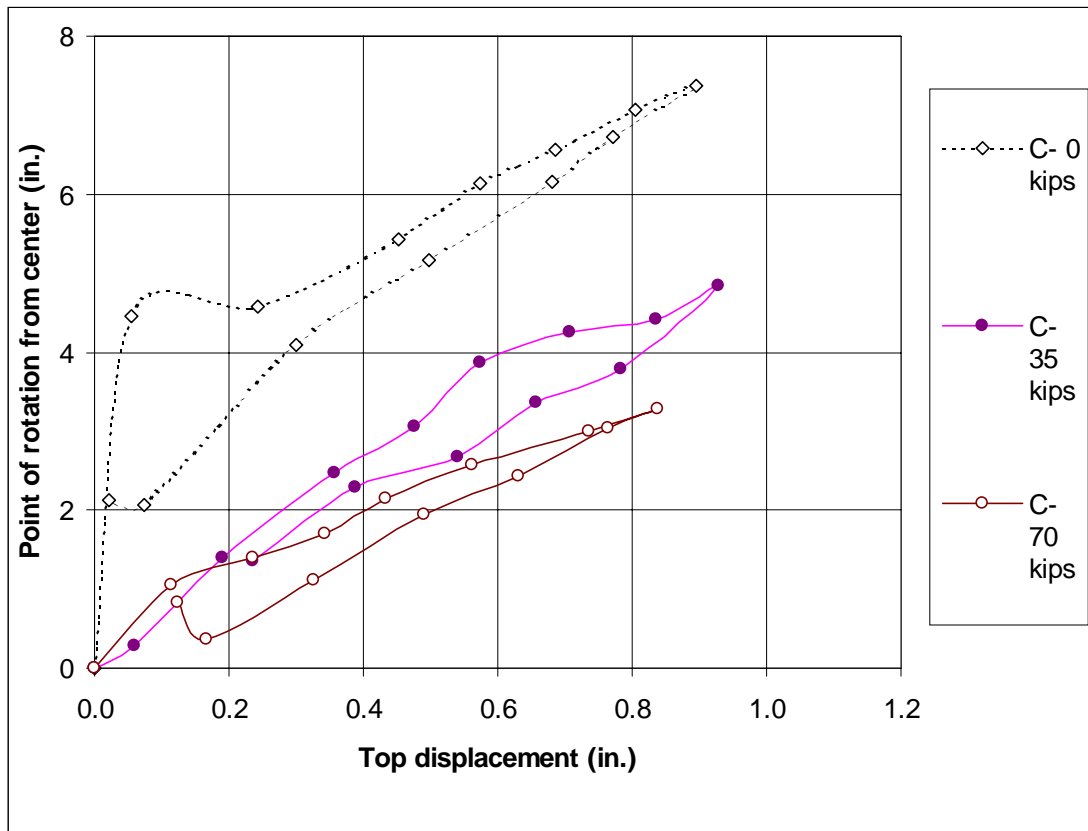
**Figure 4.20.** Point of rotation of Specimen A during static load tests

Figure 4.21. Point of rotation of Specimen B during static load tests

Figure 4.22. Point of rotation of Specimen C during static load tests

Variations of the point of rotation as a function of the relative displacement at the top of the abutment are presented in Figures 4.20, 4.21, and 4.22 for Specimens A, B, and C, respectively. The point of rotation was calculated with respect to the center of the abutment, i.e., a value of zero means that the abutment is rotating about its middle point while a value of 15 in. means that the abutment is rotating around its edge. As seen in the figures, the point of rotation moves towards the edge of the abutment as it is pulled, and moves back towards the center as the specimen is unloaded. The behavior of Specimen C is noticeably different from the behavior of the other two specimens. Specimen A and

Specimen B show similar rotational behavior, although a difference is observable. This difference in the behavior is probably responsible for the difference seen in their lateral load/displacement responses presented in Figure 4.16.
