## CHAPTER 4 - CYCLIC LOAD TESTING OF SEMI- INTEGRAL BRIDGE ABUTMENTS

### 4.1. Introduction

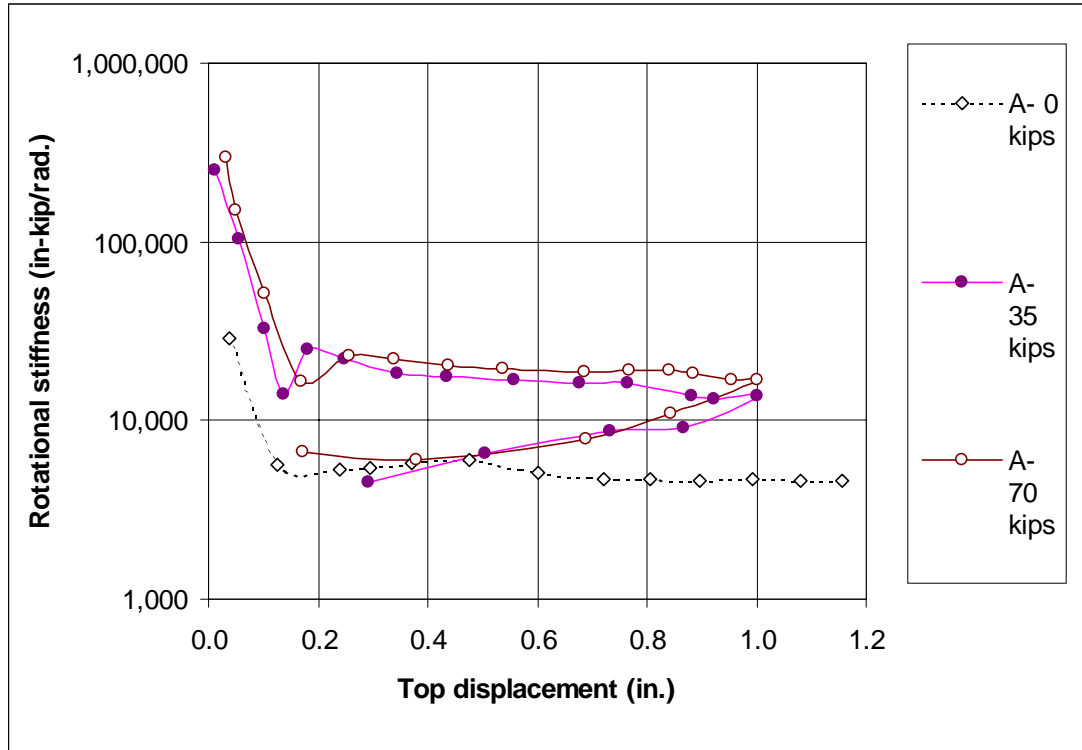
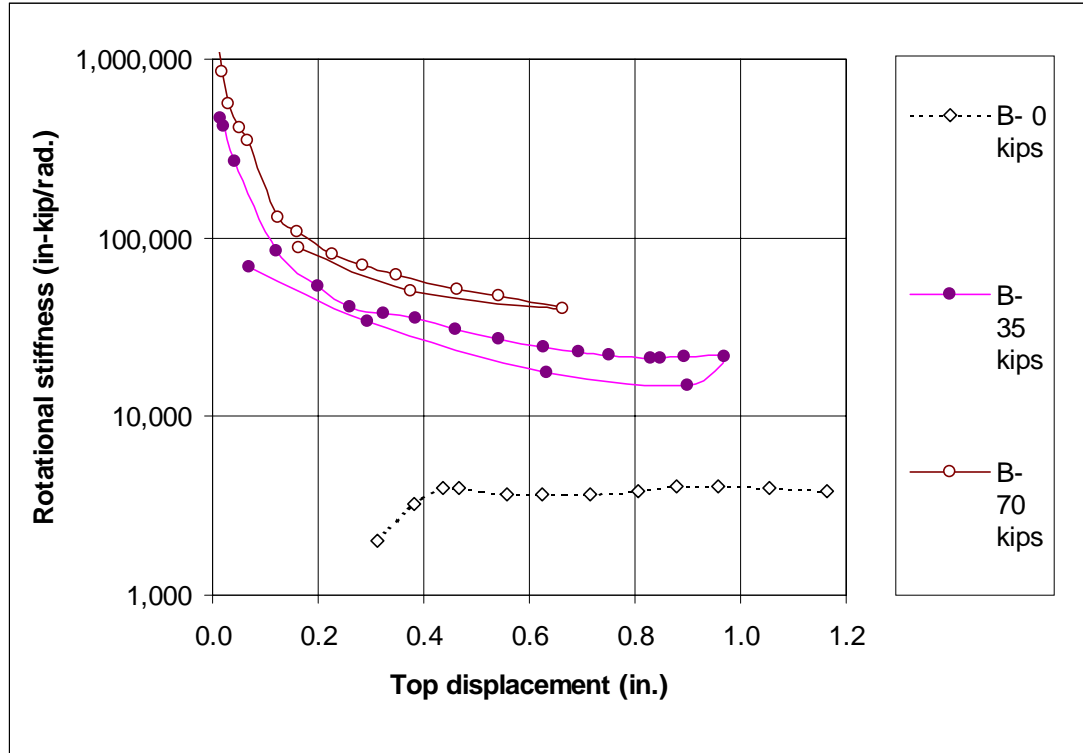
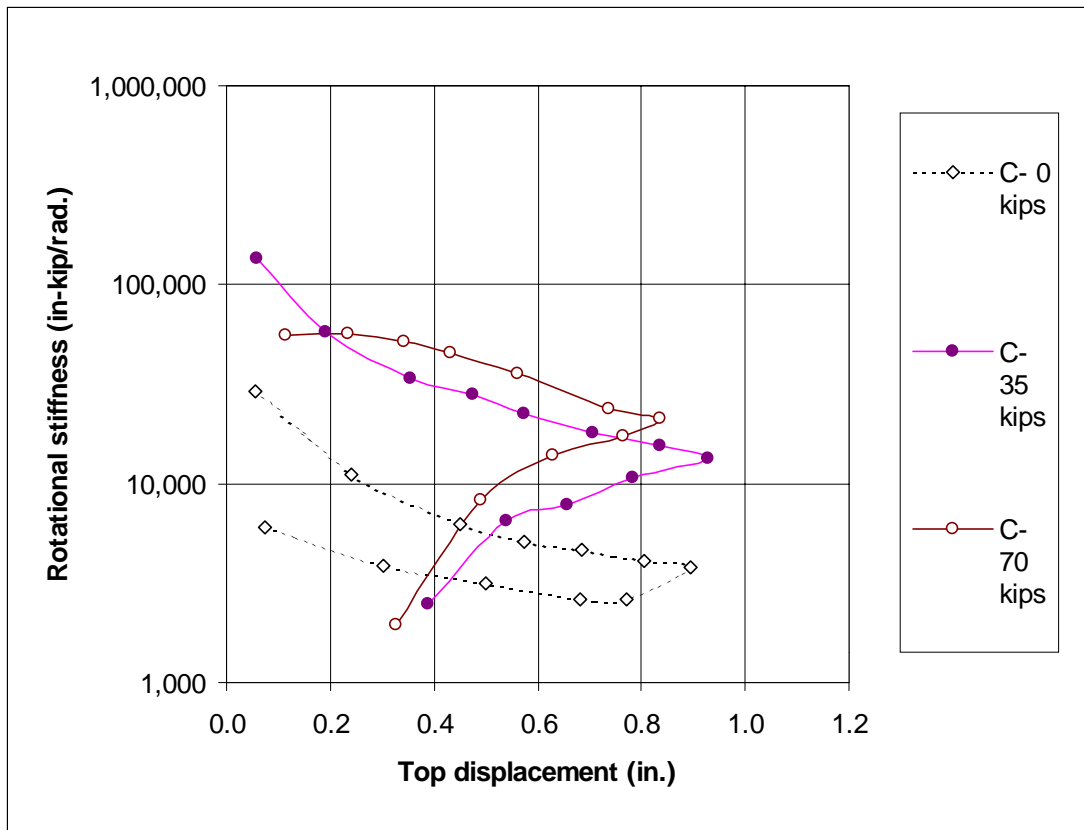
**Figure 4.23.** Rotational stiffness of Specimen A during static load tests

Figure 4.24. Rotational stiffness of Specimen B during static load tests

Figure 4.25. Rotational stiffness of Specimen C during static load tests

Rotational stiffness of the specimens was calculated as the ratio of the moment around the point of rotation to the rotation of the abutment. Variations of the rotational stiffness as a function of the relative displacement at the top of the abutment are presented in Figures 4.23, 4.24, and 4.25 for Specimens A, B, and C, respectively.

As seen in these figures, rotational stiffness decreases with increasing rotations of the abutments. The initial values of the rotational stiffness for Specimens A and B are higher than those of Specimen C. However, at higher rotations all values are converging to a constant of around 20,000 in-kip/radians. The figures also indicate that the abutments have higher rotational stiffness with higher vertical load, though the effect of the vertical load is not significant.

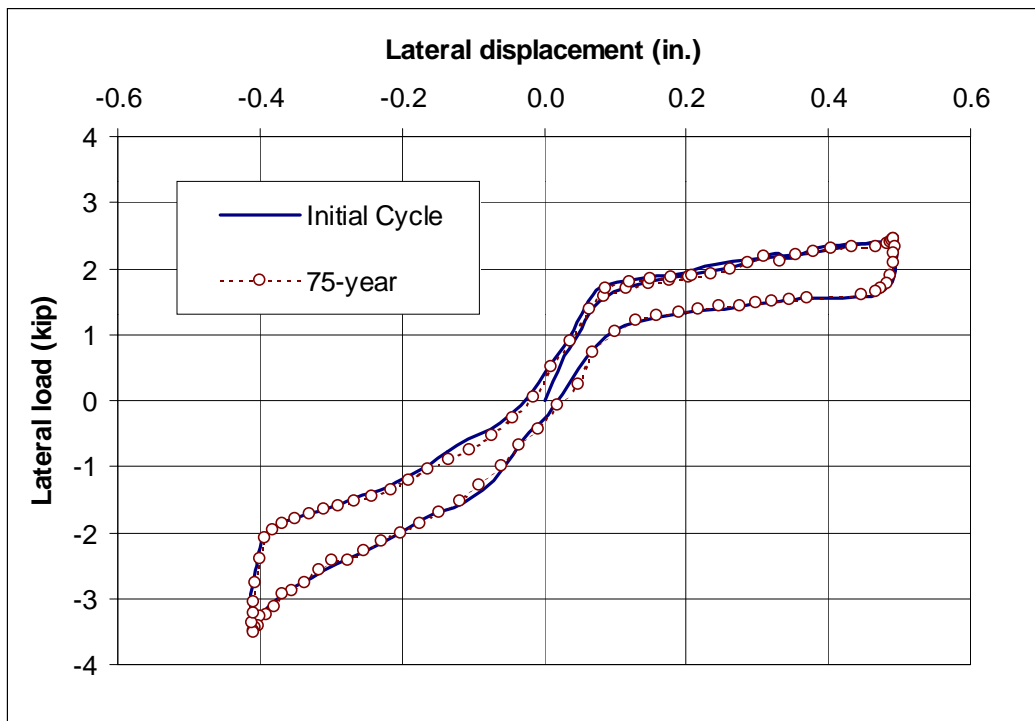
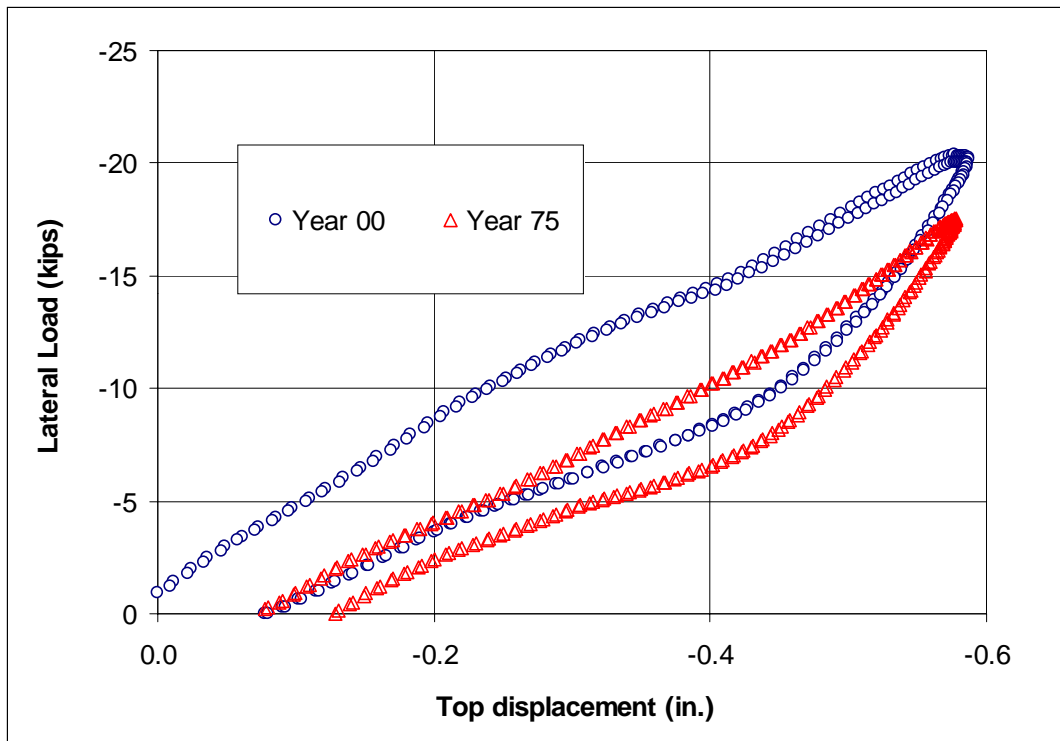
**Figure 4.26.** Lateral load/displacement relationship of Specimen B for zero vertical load during cyclic tests

**Figure 4.27.** Lateral load/displacement relationship of Specimen B for 35-kip vertical load during cyclic tests

Figure 4.26 shows the lateral load hysteresis loops for Specimen B under zero vertical load while Figure 4.27 shows a similar graph for the same specimen under a vertical load of 35 kips. The latter figure shows half the loops of the data because the data on the other half was unreliable as it was affected by external factors. As seen in these figures, the damage introduced by over 27,000 cycles is almost non-existent.

Figure 4.26 indicates no damage at all while Figure 4.27 indicates some softening in load response for 35-kip vertical loading.

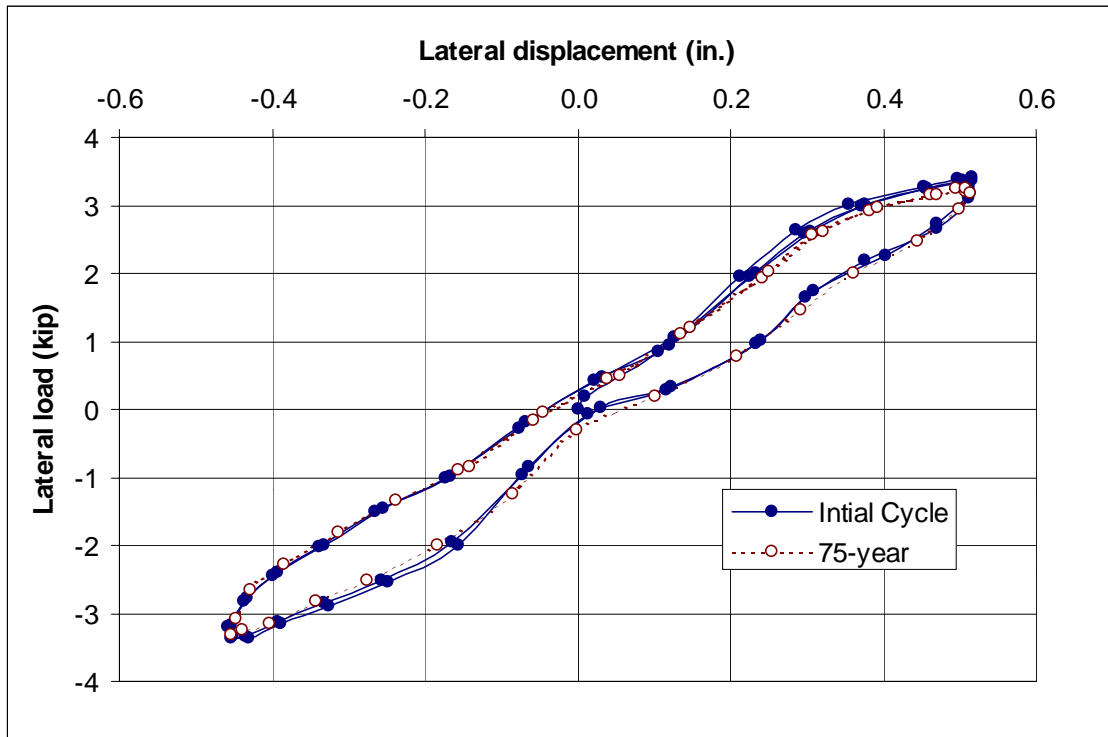
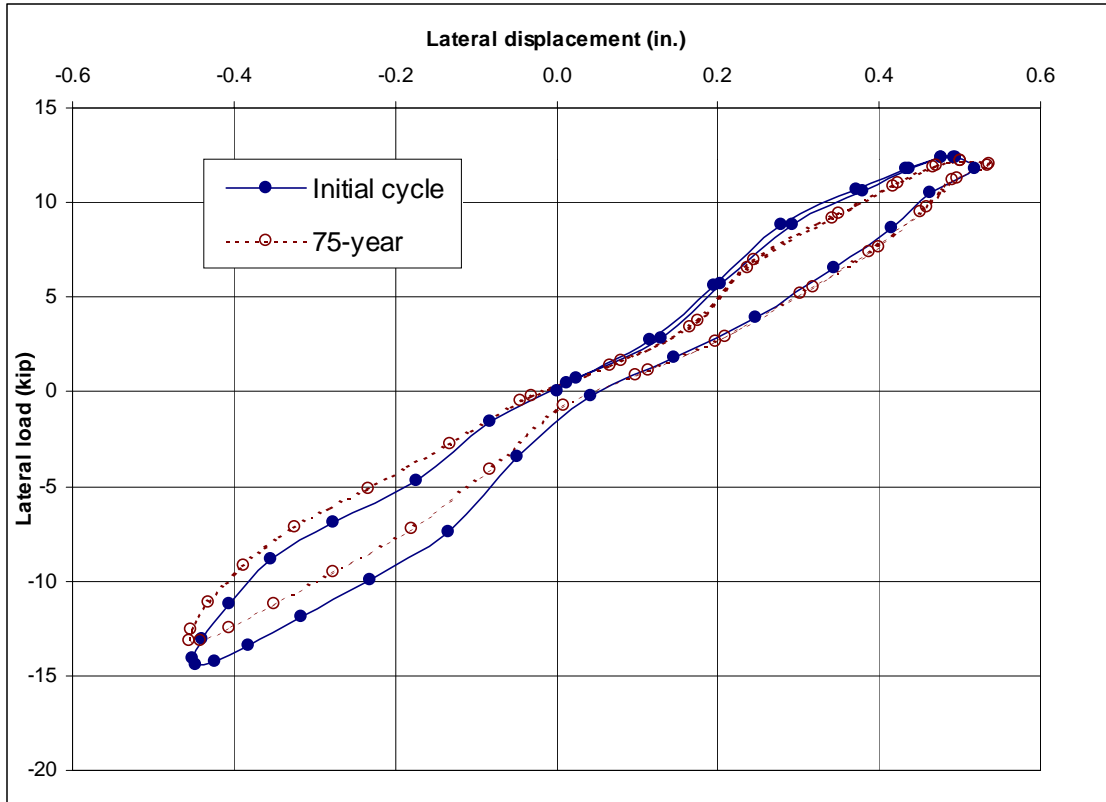
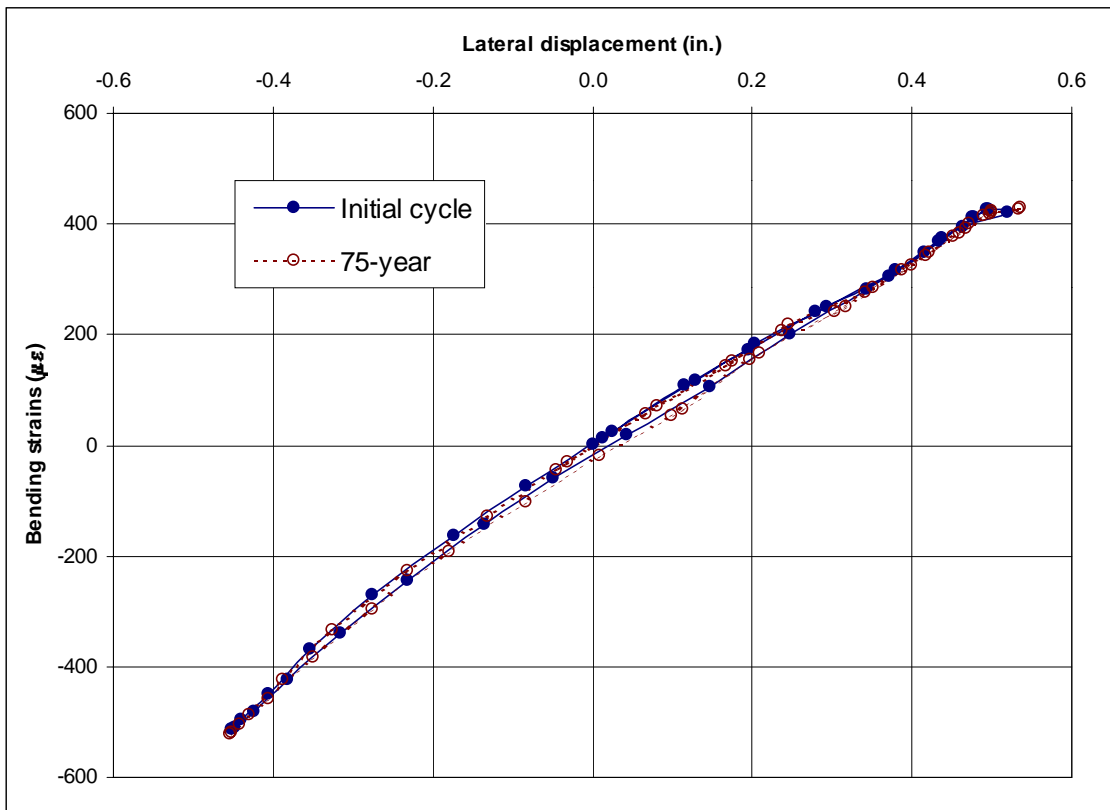
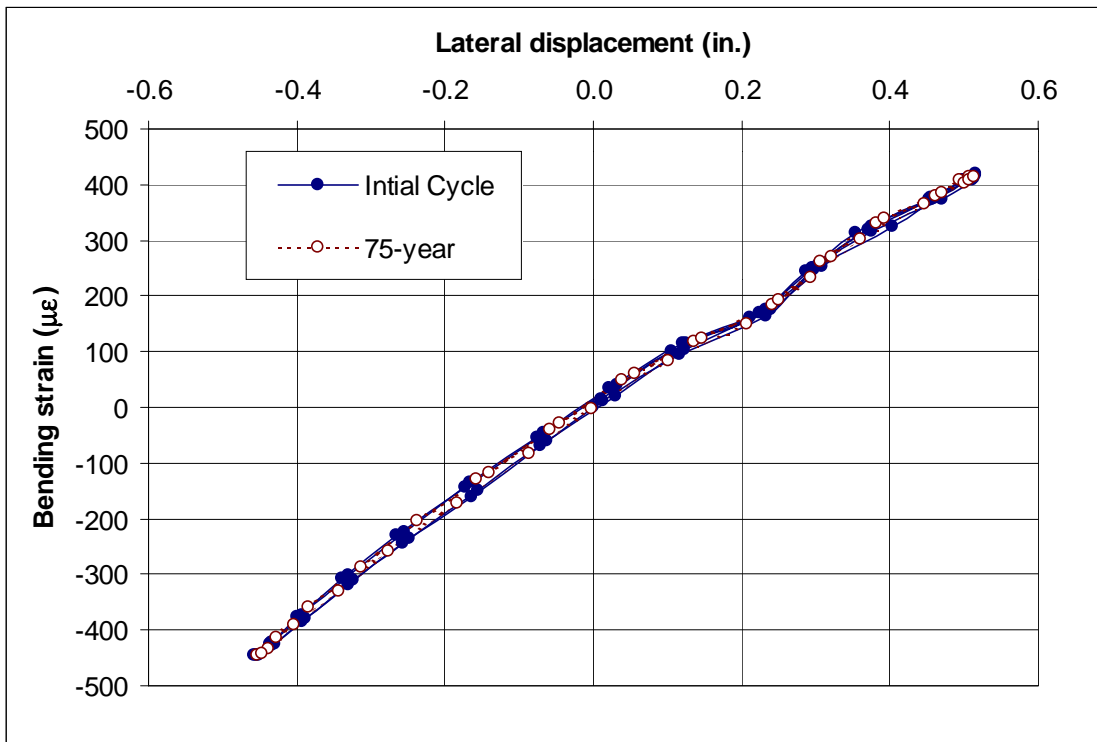
**Figure 4.28.** Lateral load/displacement relationship of Specimen C for zero vertical load during cyclic tests

**Figure 4.29.** Lateral load/displacement relationship of Specimen C for 35-kip vertical load during cyclic tests

**Figure 4.30.** Bending strain/displacement relationship of Specimen C for zero vertical load during cyclic tests

**Figure 4.31.** Bending strain/displacement relationship of Specimen C for 35-kip vertical load during cyclic tests

Lateral load hysteresis loops for Specimen C under 0- and 35-kip vertical loads are shown in Figures 4.28, and 4.29, respectively. As evident in both figures, there is no sign of damage. The load/displacement behavior of the specimen is virtually unchanged after 75-years of displacement cycles. Bending strains of the dowels also show no change in response with cyclic loading as depicted in Figures 4.30 and 4.31 for 0- and 35-kip vertical loading, respectively.

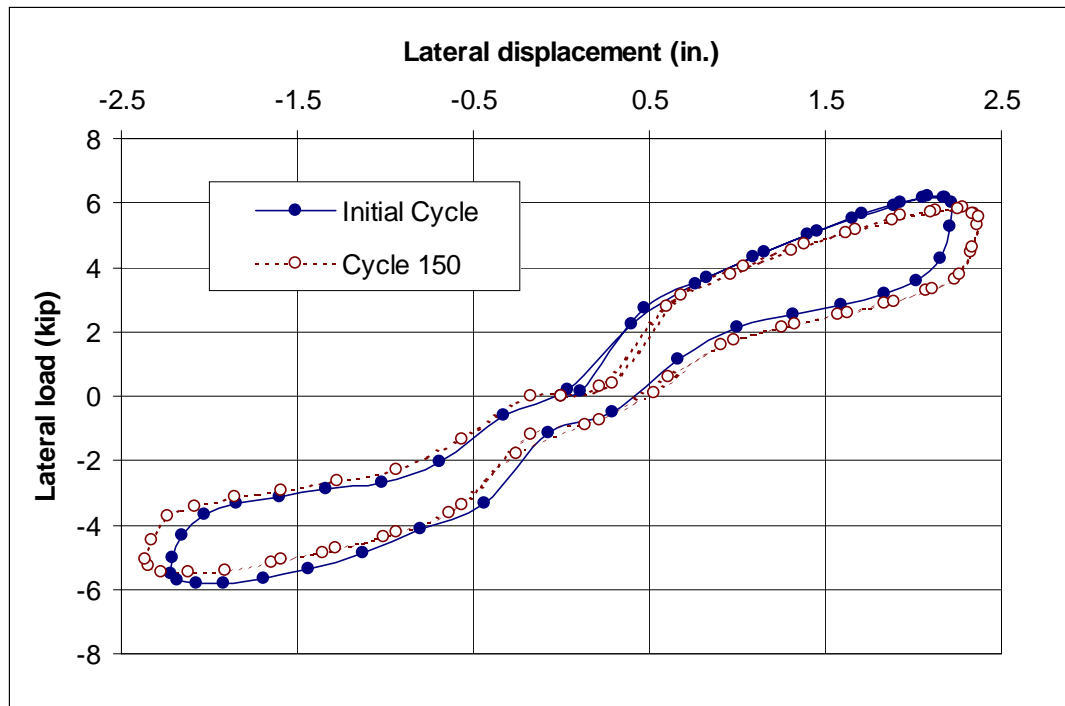
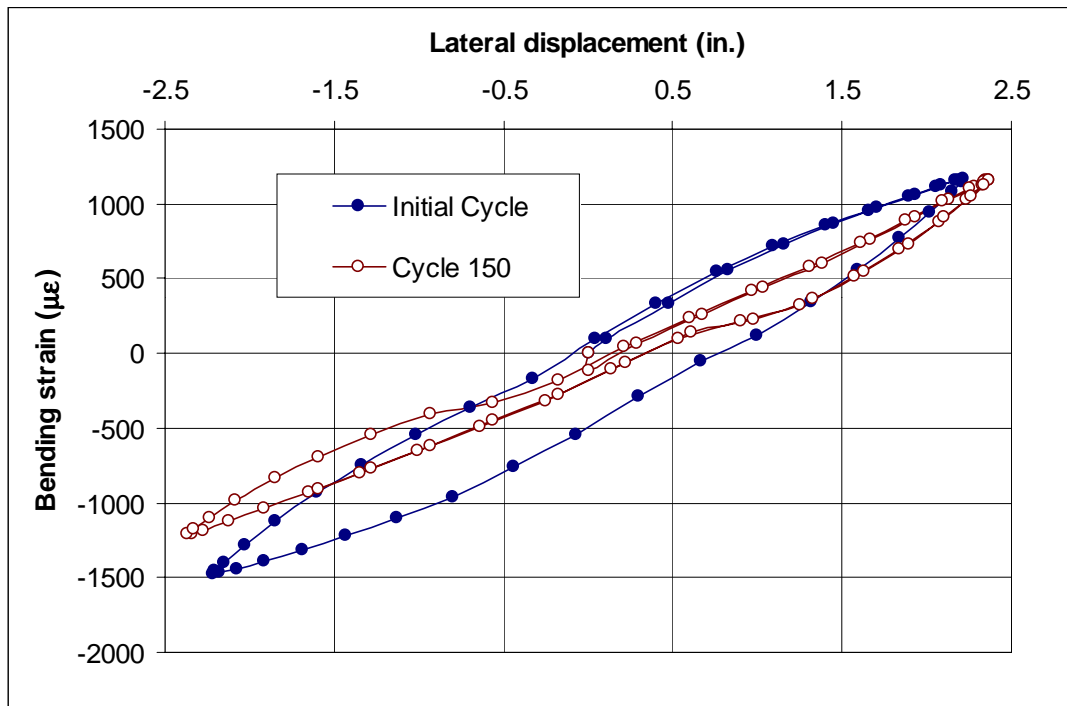
**Figure 4.32.** Lateral load/displacement relationship of Specimen C for zero vertical load during large displacement cyclic tests

**Figure 4.33.** Bending strain/displacement relationship of Specimen C for zero vertical load during large displacement cyclic tests

Specimen C was also subject to 150 cycles consisting of  $\pm 2.5$  inch displacements cycles at the top of the abutment after the completion of the previous cyclic test program in an attempt to fail the dowels. The lateral load and the bending strain responses of the specimen are presented in Figures 4.32 and 4.33, respectively. No vertical load was applied to the specimen. Only the responses of the first and the 150<sup>th</sup> cycles are shown in these figures. Even at these higher rotations, the specimen was able to handle the loads with no sign of damage. The maximum bending strain seen in Figure 4.33 is slightly higher than the yield strain ( $\sim 1,400 \mu\epsilon$ ) of the dowels.
